## Roof Instability:

### What Reportable Noninjury Roof Falls in Underground Coal Mines Can Tell Us

T.S. Bajpayee, Deno M. Pappas, and John L. Ellenberger

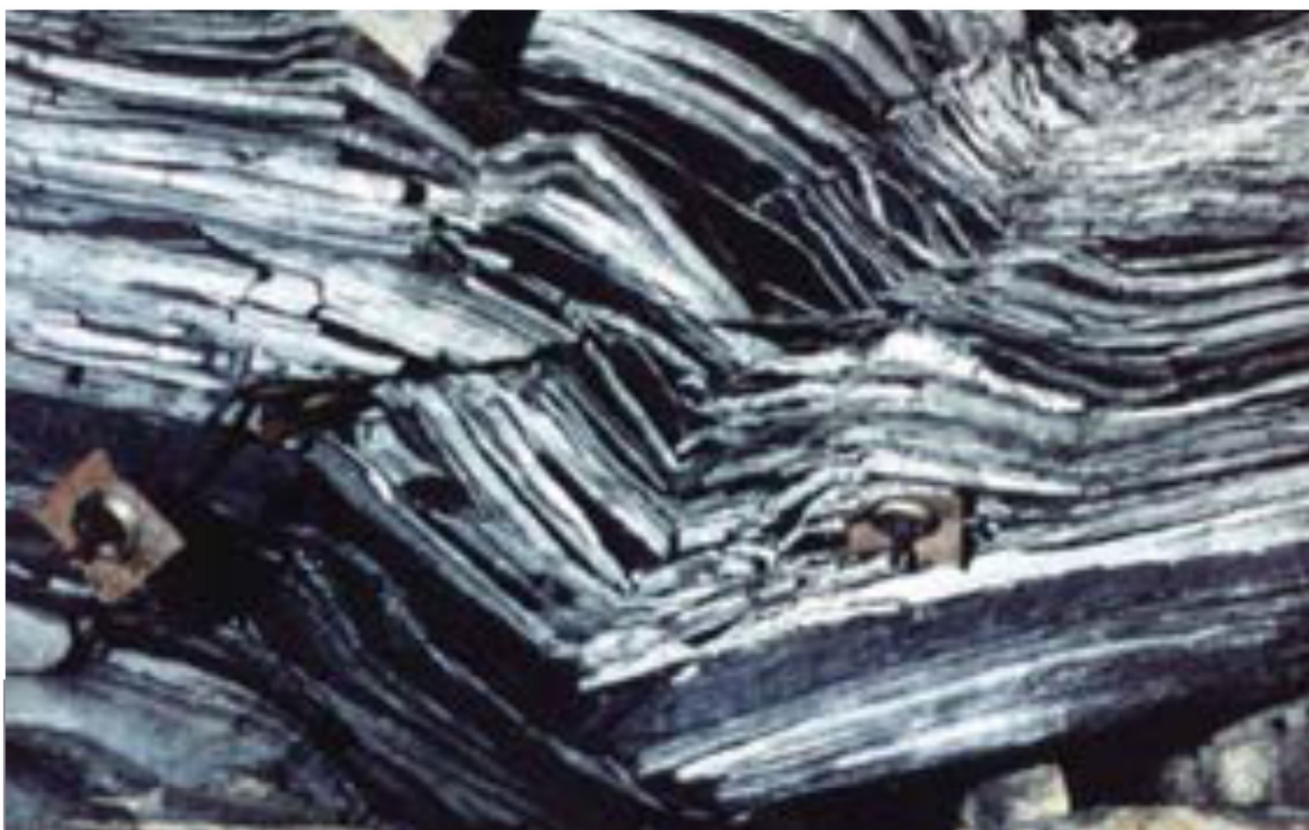
**Photo 1.**  
Failure of laminated roof layers in a coal mine.

**Laminated Roof**—Presence of thin laminations in a weak roof beam can contribute to entry failure. Laminations in the roof beam cause it to be subdivided into multiple thin beams. Weak, thin beams tend to separate and deflect downward into the mine entry. In addition, mining-induced stress could initiate progressive shear failure in thin layers of roof beam (Iannacchione, Esterhuizen, Bajpayee, et al., 2005). The interface material between adjacent layers may fail as well, causing differential movement in the layers and thereby weakening the overall rockmass strength. In the narratives, the presence of laminations in the immediate roof beam was reported as the second largest contributory factor for roof falls (Figure 6). Photo 1 shows failure of laminated roof in a coal mine (Esterhuizen & Bajpayee, 2012).

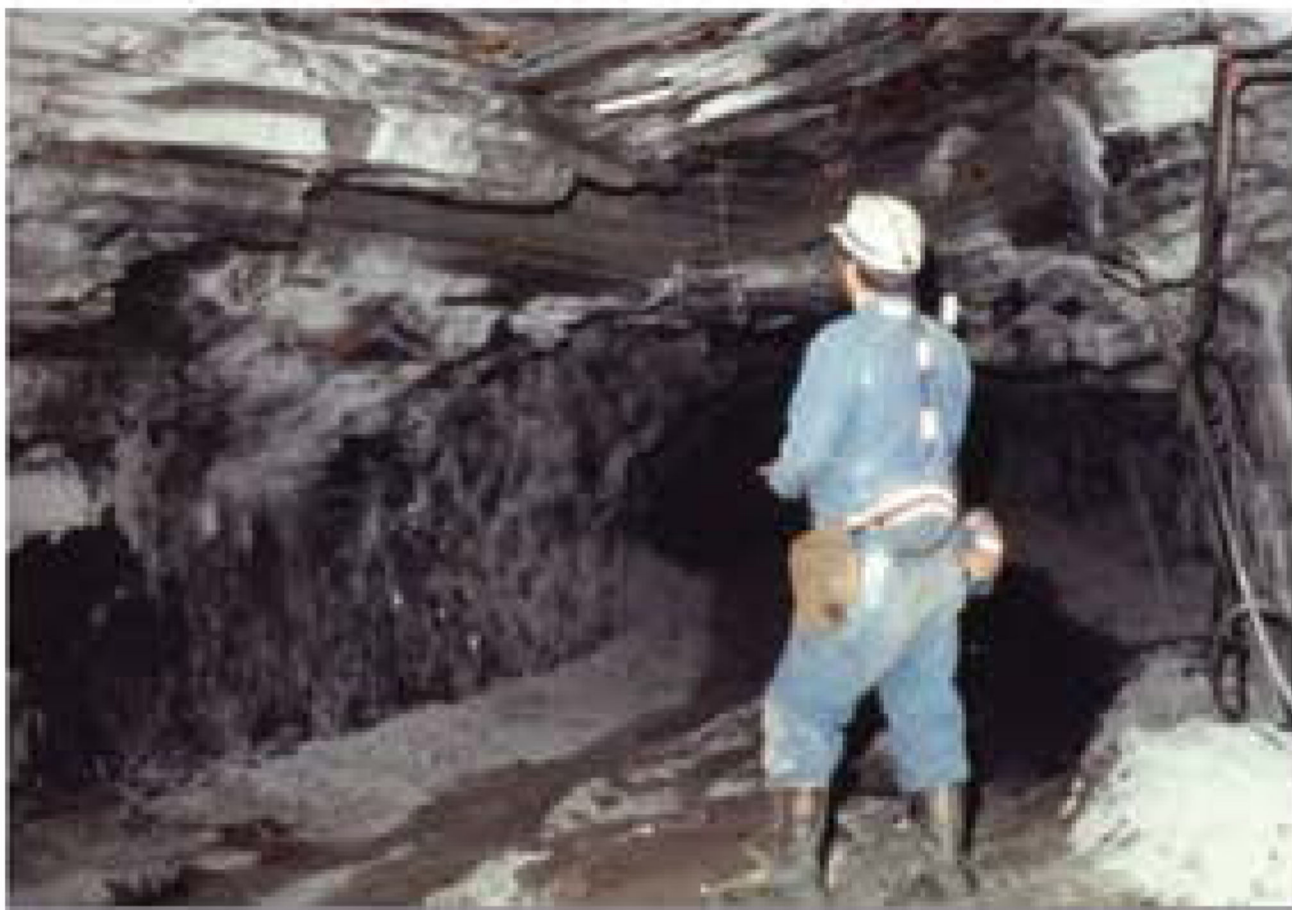
**Photo 2.**  
Initiation of roof cutter in a coal mine.

**Cutter**—The cutter category also includes roof falls due to the presence of high horizontal stress. Horizontal stress associated with poor rock quality is known to have initiated cutter failure in the Illinois Coal Basin (Molinda, 2003). (In this context, the word *cutter* is synonymous with the term *gutter* or *roof gutter*.) Furthermore, when the horizontal stress exceeds the vertical stress, it may cause cutter failure. Photo 2 shows initiation of roof cutter in a coal mine (Esterhuizen & Bajpayee, 2012). No unique solution exists for controlling or avoiding cutter roof failure (Hill, 1986). Even at shallow depths, horizontal stress is a concern for entry stability. Mark and Mucho (1994) and Su and Hasenfus (1995) reported that horizontal stress is often higher than the vertical stress in coal-bearing rock formation.
